SMOKE TESTING OBSERVATION SUMMARY

Western Run Pilot Project - Baltimore Maryland

Metcalf & Eddy

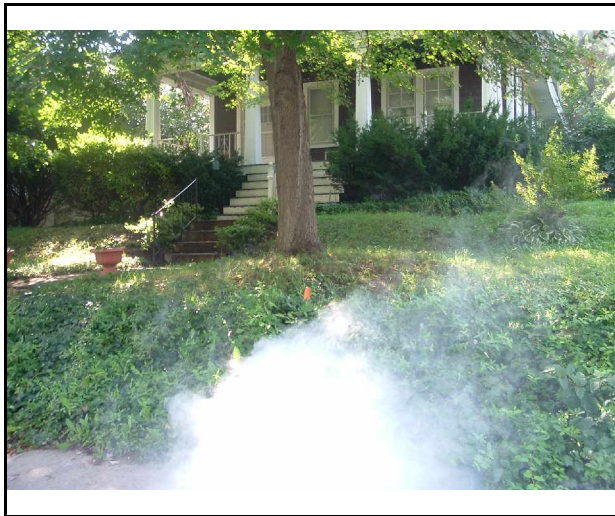
Photo No: 3

Unique Test ID	23	Date:	8/16/2004	MeterBasin:	01_WR13
Observer ID:	A	Crew:	T-1	Dye Test Recommended:	N
Defect No:	3	Setup No:	1	Priority CCTV:

House Number	Street Prefix:	Street Name:	Street Type:
2417		Crest	ROAD

Source Type:	04= Cleanout	Location:	7=Yard-Front	Severity:
Sector:	2=Private	Drainage Area:	25

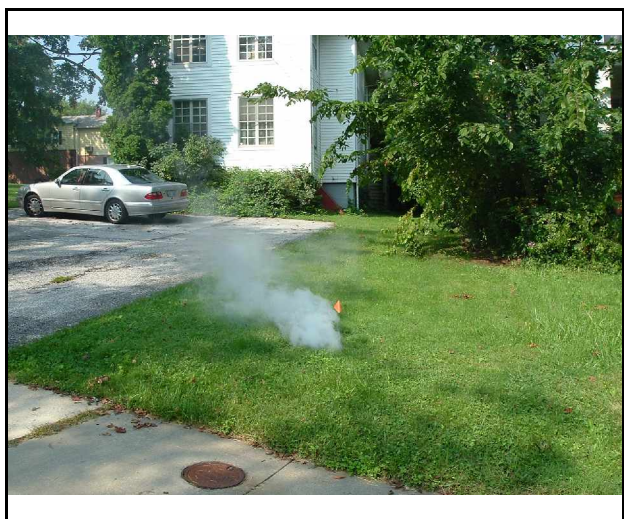
Photo No: 1

House Number	Street Prefix:	Street Name:	Street Type:
5728		Pimlico	ROAD

Source Type:	04= Cleanout	Location:	7=Yard-Front	Severity:
---------------------	--------------	------------------	--------------	------------------

Comments: Front yd / clean out

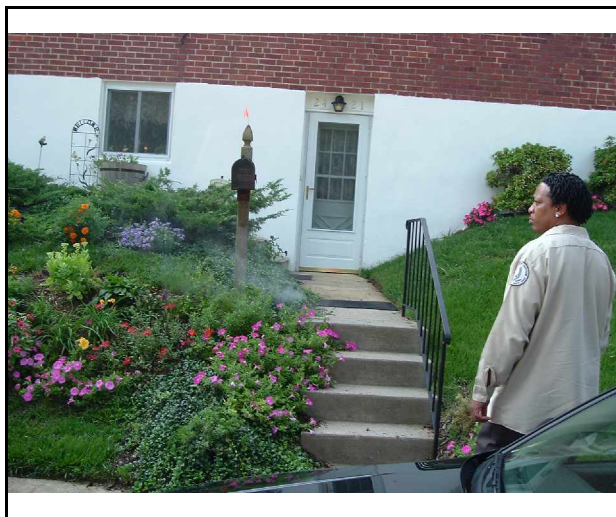
Photo No: 2

House Number	Street Prefix:	Street Name:	Street Type:
2421		Crest	ROAD

Source Type:	04= Cleanout	Location:	7=Yard-Front	Severity:
Sector:	2=Private	Drainage Area:	50	
Comments:	Clean out

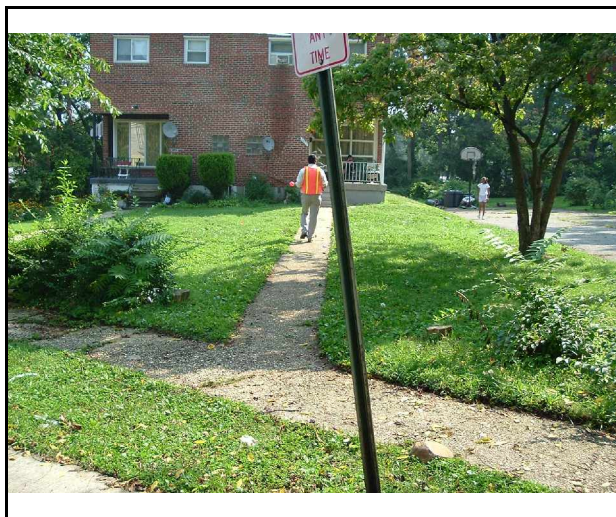
Photo No: 4

House Number	Street Prefix:	Street Name:	Street Type:
5727		Pimlico	ROAD

Source Type:	04= Cleanout	Location:	7=Yard-Front	Severity:
---------------------	--------------	------------------	--------------	------------------

Comments: Clean out /front yard

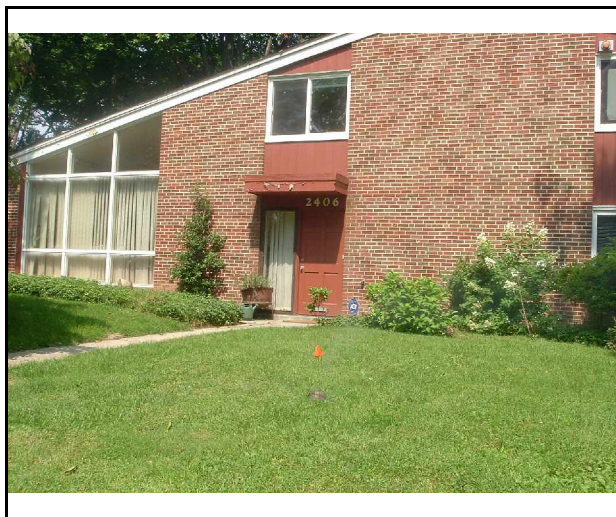
Photo No: 4

House Number	Street Prefix:	Street Name:	Street Type:
2406		Rockwood	AVE

Source Type:	04= Cleanout	Location:	7=Yard-Front	Severity:
Sector:	2=Private	Drainage Area:	25

Comments: Broken cap on clean out

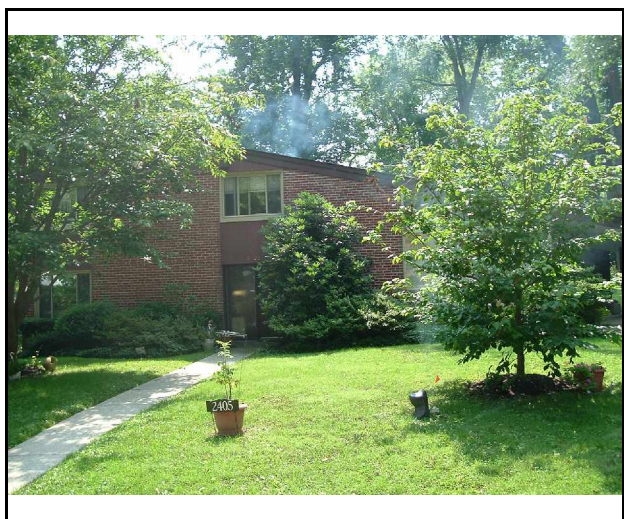
Photo No: 5

House Number	Street Prefix:	Street Name:	Street Type:
2405		Rockwood	AVE

Source Type:	04= Cleanout	Location:	7=Yard-Front	Severity:
Sector:	2=Private	Drainage Area:	50

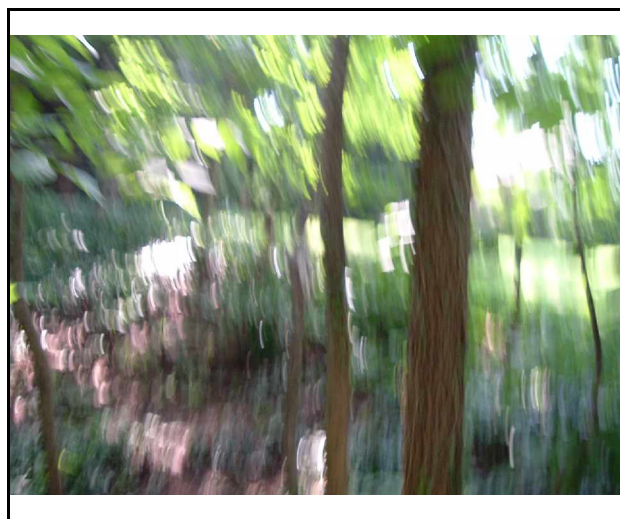
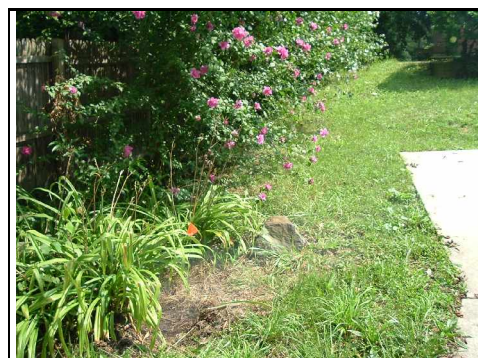
House Number	Street Prefix:	Street Name:	Street Type:
5811		Pimlico	ROAD

Source Type:	04= Cleanout	Location:	9=Yard-Side	Severity:
Sector:	2=Private	Drainage Area:	100

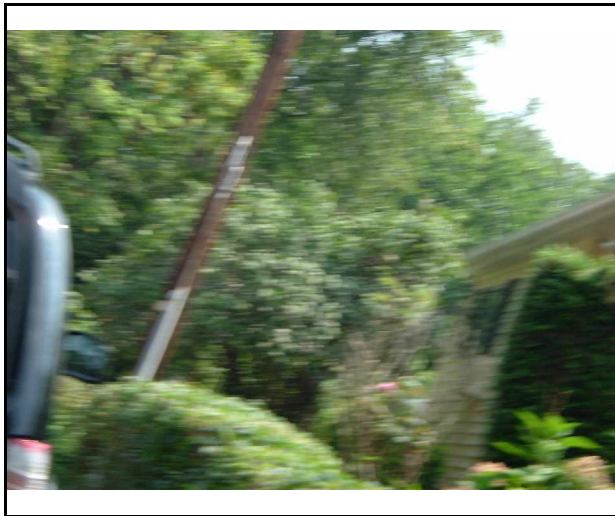
Photo No: 8

House Number	5807	Street Prefix:		Street Name:	Pimlico	Street Type:	ROAD
Source Type:	04= Cleanout	Location:	7=Yard-Front	Severity:			
Sector:	2=Private	Drainage Area:	100				
Comments:

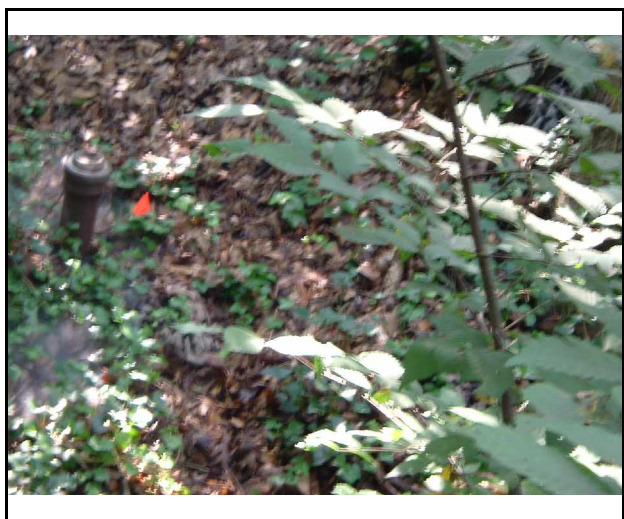
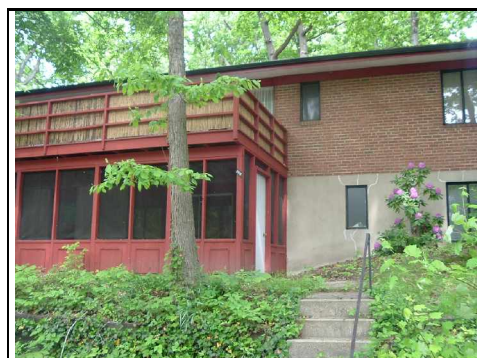
House Number	Street Prefix:	Street Name:	Street Type:
5826		Pimlico	ROAD

Source Type:	02= Service Line	Location:	9=Yard-Side	Severity:
Sector:	2=Private	Drainage Area:	150

Comments: Not a cap defect - smoke around c/o stack at service - served on Greenspring Ave

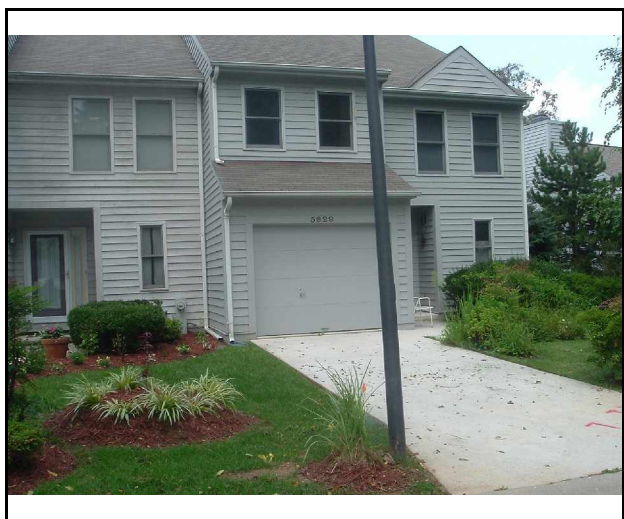
Photo No: 5

House Number	Street Prefix:	Street Name:	Street Type:
5828		Pimlico	ROAD

Source Type:	04= Cleanout	Location:	7=Yard-Front	Severity:
Sector:	2=Private	Drainage Area:	25	
Comments:	Cracked Clean out

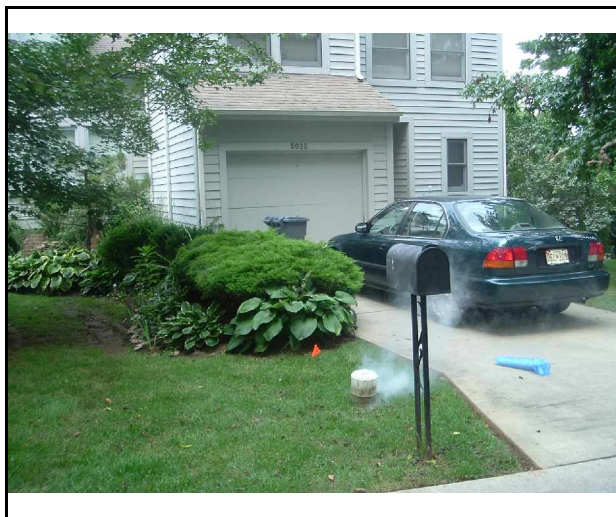
Photo No: 6

House Number	Street Prefix:	Street Name:	Street Type:
5832		Pimlico	ROAD

Source Type:	04= Cleanout	Location:	7=Yard-Front	Severity:
Sector:	2=Private	Drainage Area:	25

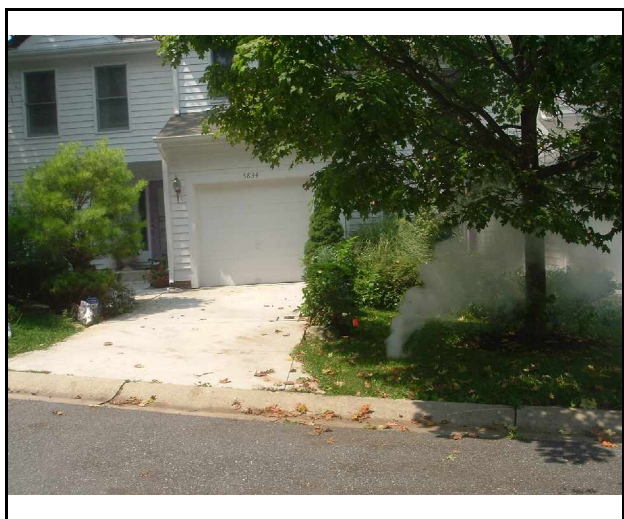
Photo No: 7

House Number	Street Prefix:	Street Name:	Street Type:
5834		Pimlico	ROAD

Source Type:	04= Cleanout	Location:	7=Yard-Front	Severity:
---------------------	--------------	------------------	--------------	------------------

Comments: Missing Cap

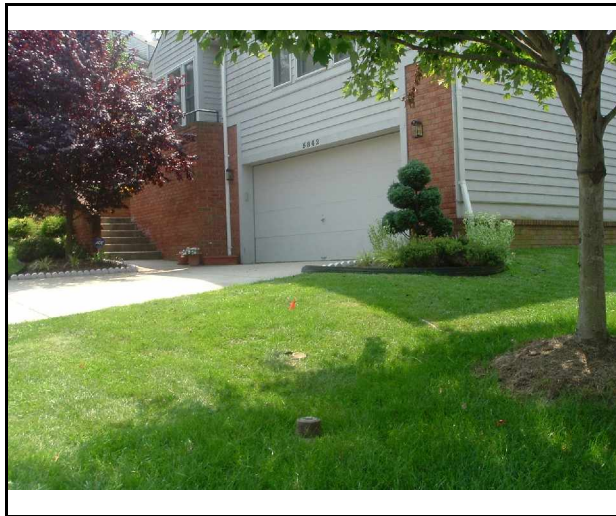
Photo No: 8

House Number	Street Prefix:	Street Name:	Street Type:
5842		Pimlico	ROAD

Source Type:	04= Cleanout	Location:	7=Yard-Front	Severity:
Sector:	2=Private	Drainage Area:	25	
Comments:	Missing Cap

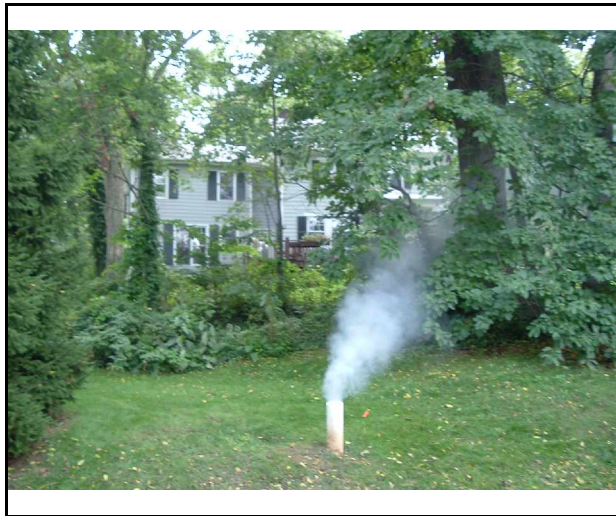
Photo No: 10

House Number	Street Prefix:	Street Name:	Street Type:
5816		Pimlico	ROAD

Source Type:	04= Cleanout	Location:	7=Yard-Front	Severity:
Sector:	2=Private	Drainage Area:	100	
Comments:	Bt. Apts. - Fr.Yrd.

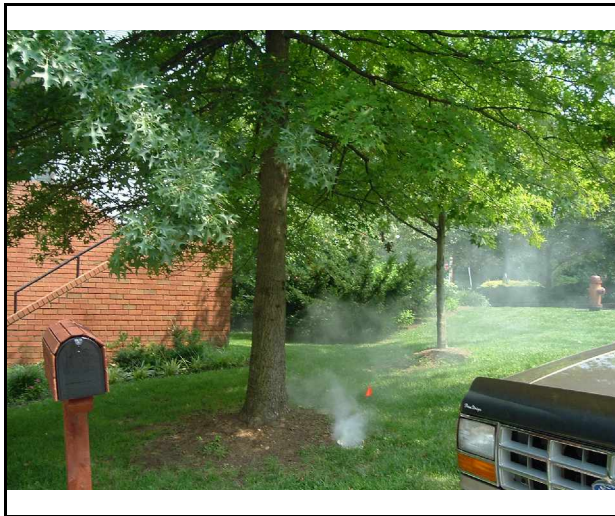
Photo No: 11

House Number	5890	Street Prefix:		Street Name:	Pimlico	Street Type:	ROAD
Source Type:	04= Cleanout	Location:	7=Yard-Front	Severity:			
Sector:	2=Private	Drainage Area:	100				
Comments:	Bt. Apts. - Fr.Yrd.

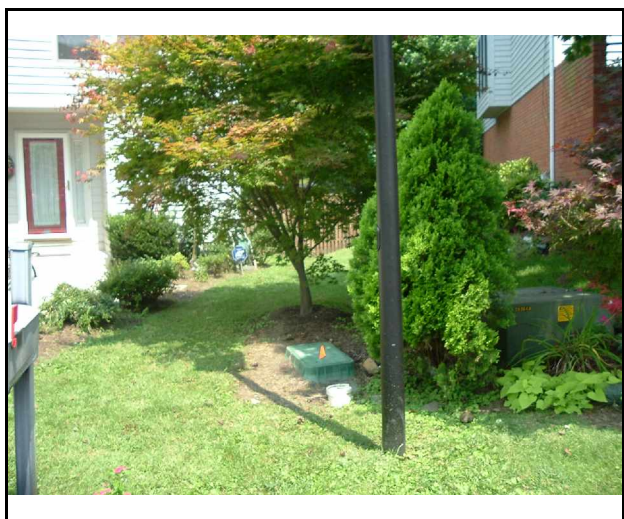
Photo No: 12

Unique Test ID	26	Date:	8/16/2004	MeterBasin:	01_WR18
Observer ID:	B	Crew:	T-1	Dye Test Recommended:	N
Defect No:	3	Setup No:	4	Priority CCTV:

Comments: BT. Apts. - Fr.Yd.

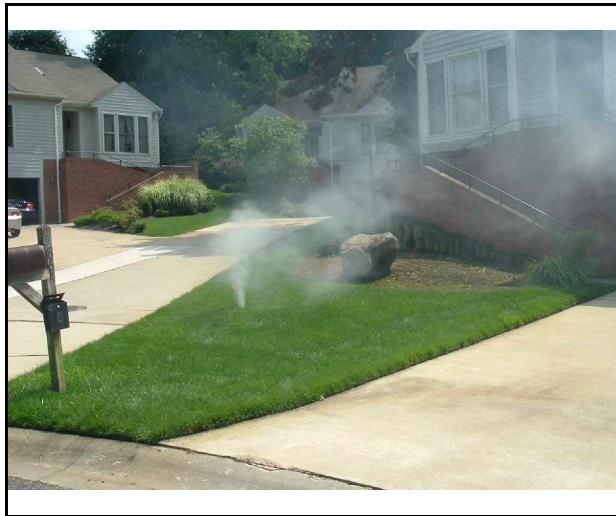
Unique Test ID	27	Date:	8/16/2004	MeterBasin:	01_WR18
Observer ID:	B	Crew:	T-1	Dye Test Recommended:	N
Defect No:	1	Setup No:	5	Priority CCTV:

Comments: clean out

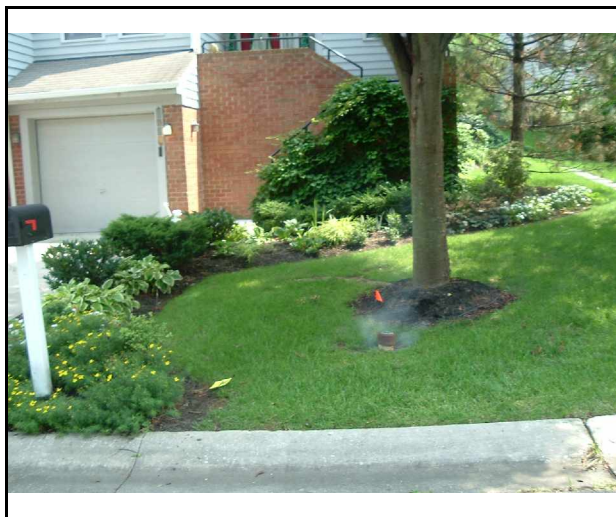
Unique Test ID	27	Date:	8/16/2004	MeterBasin:	01_WR18
Observer ID:	B	Crew:	T-1	Dye Test Recommended:	N
Defect No:	2	Setup No:	5	Priority CCTV:

Comments: clean out

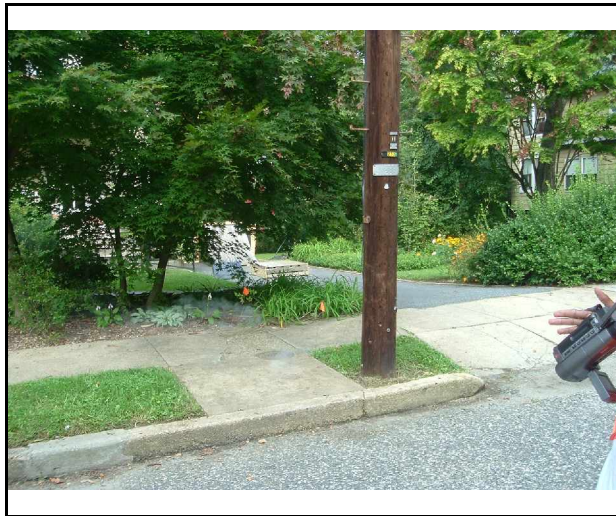
Unique Test ID	28	Date:	8/17/2004	MeterBasin:	01_WR18
Observer ID:	A	Crew:	T-1	Dye Test Recommended:	N
Defect No:	1	Setup No:	1	Priority CCTV:

House Number	Street Prefix:	Street Name:	Street Type:	
5704		Rusk	AVE	
Source Type:	02= Service Line	Location:	1=Paved Concrete	Severity:
Sector:	1=Public	Drainage Area:	25	
Comments:	sidewalk
